Hot Corrosion of Single-Crystal NiAl-X Alloys

James A. Nesbitt
Lewis Research Center, Cleveland, Ohio

National Aeronautics and
Space Administration

May 1998

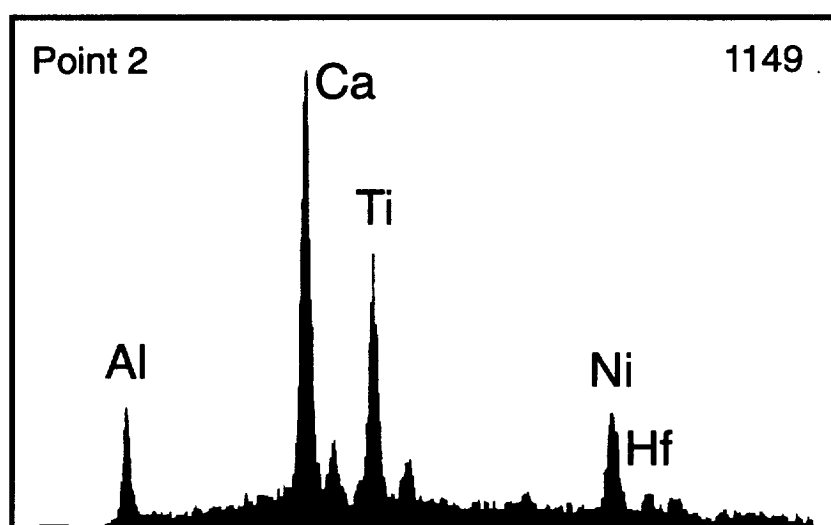
Fig. 65 EDS spectra of the dark plates (point 2) shown in Fig. 64d.

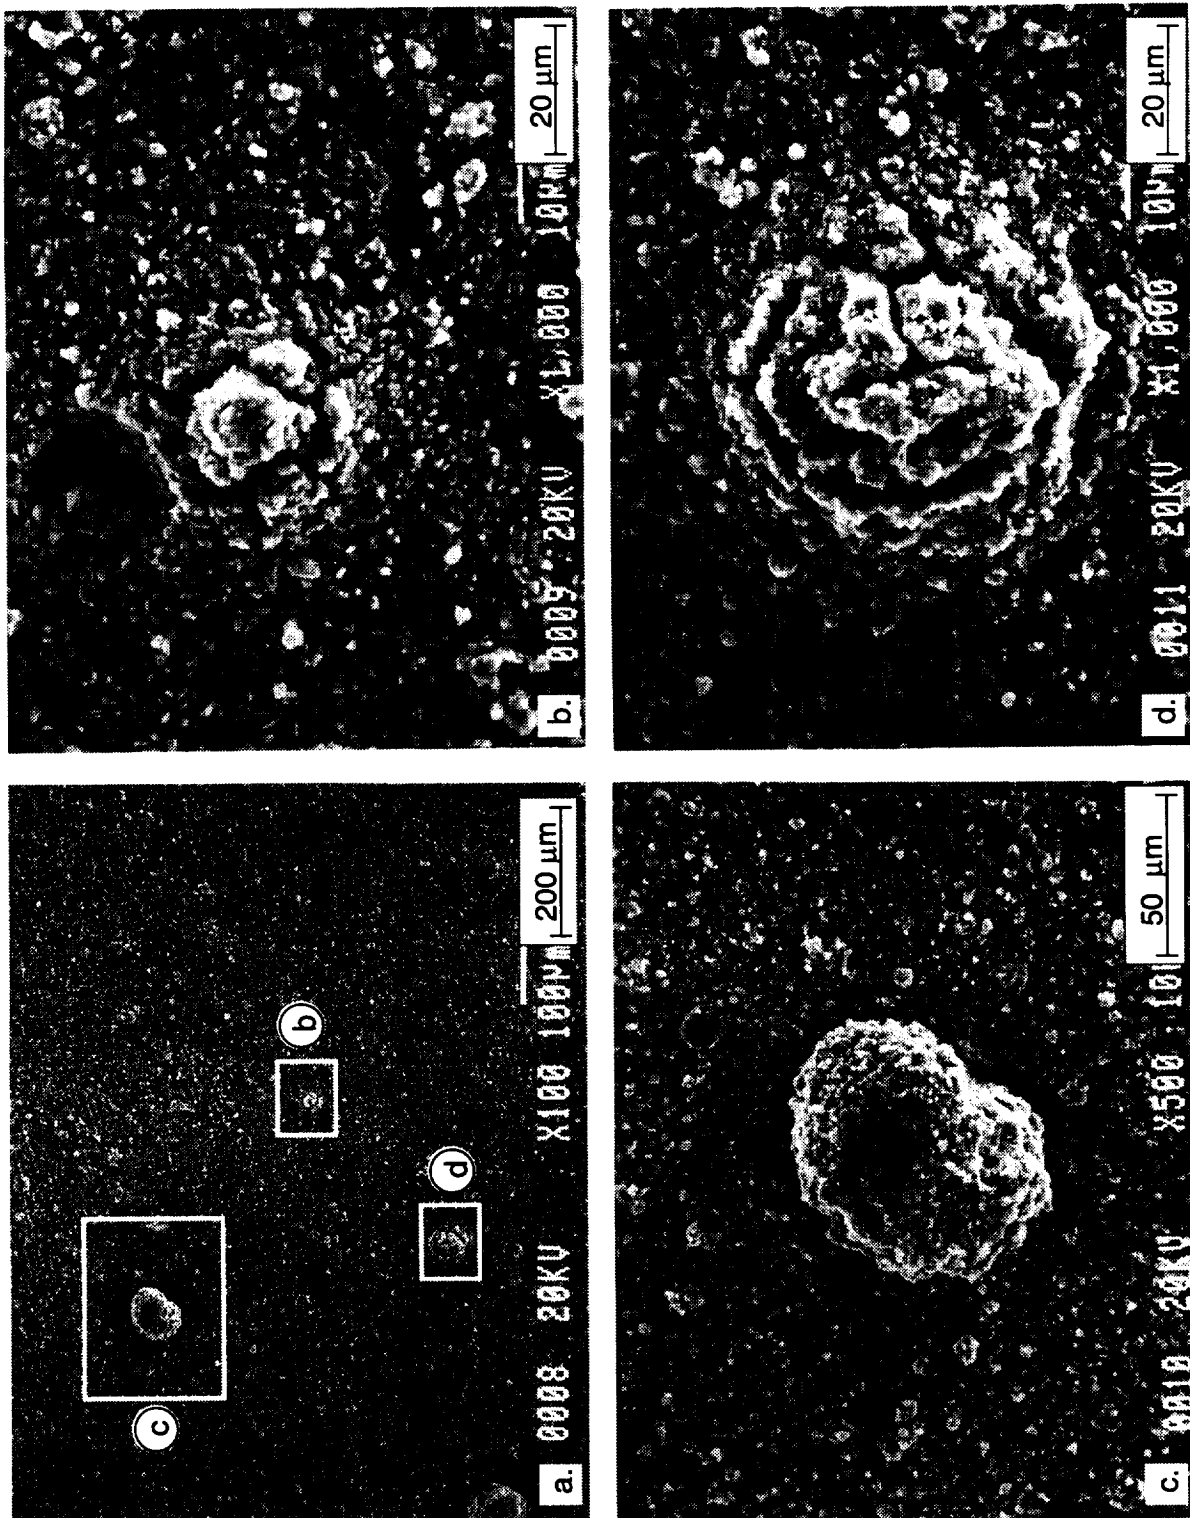
Fig. 66 SEM micrographs of the "smooth" curved surface of AFN20 after 300 cycles (right end of Fig59c,d), (b),(c) and (d) are magnified views of the boxed areas in (a).

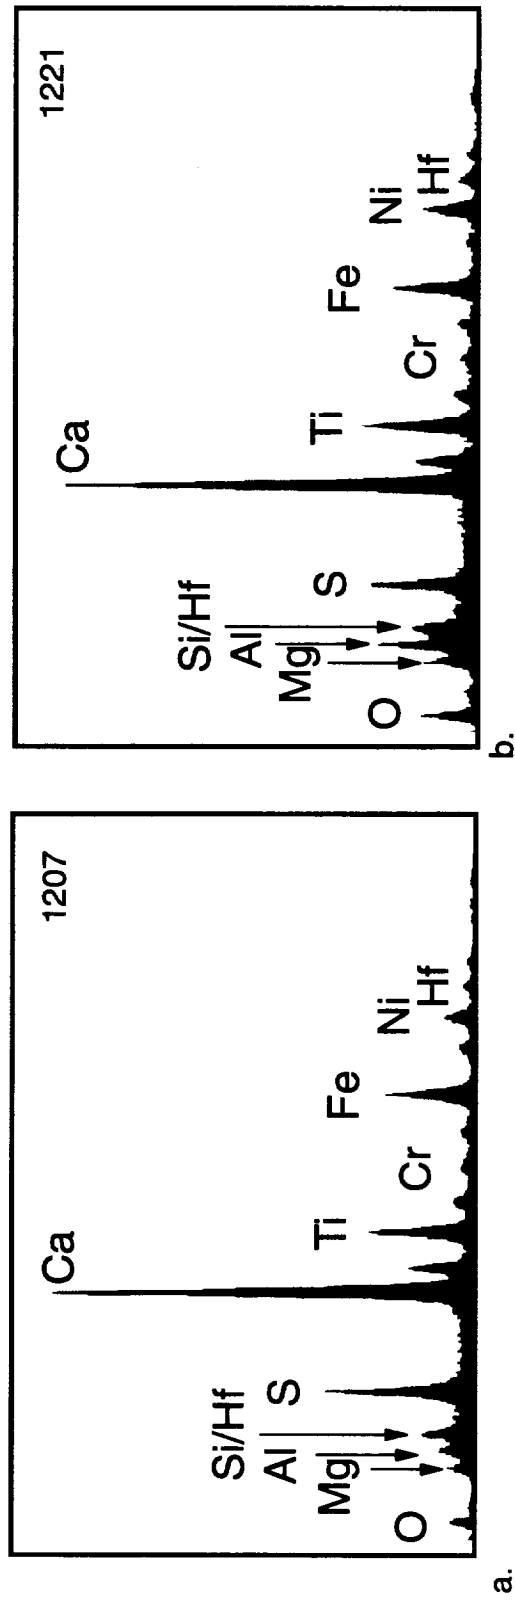
Fig. 67 EDS spectra of the nodule shown in Fig. 66c and the mound in Fig. 66d.

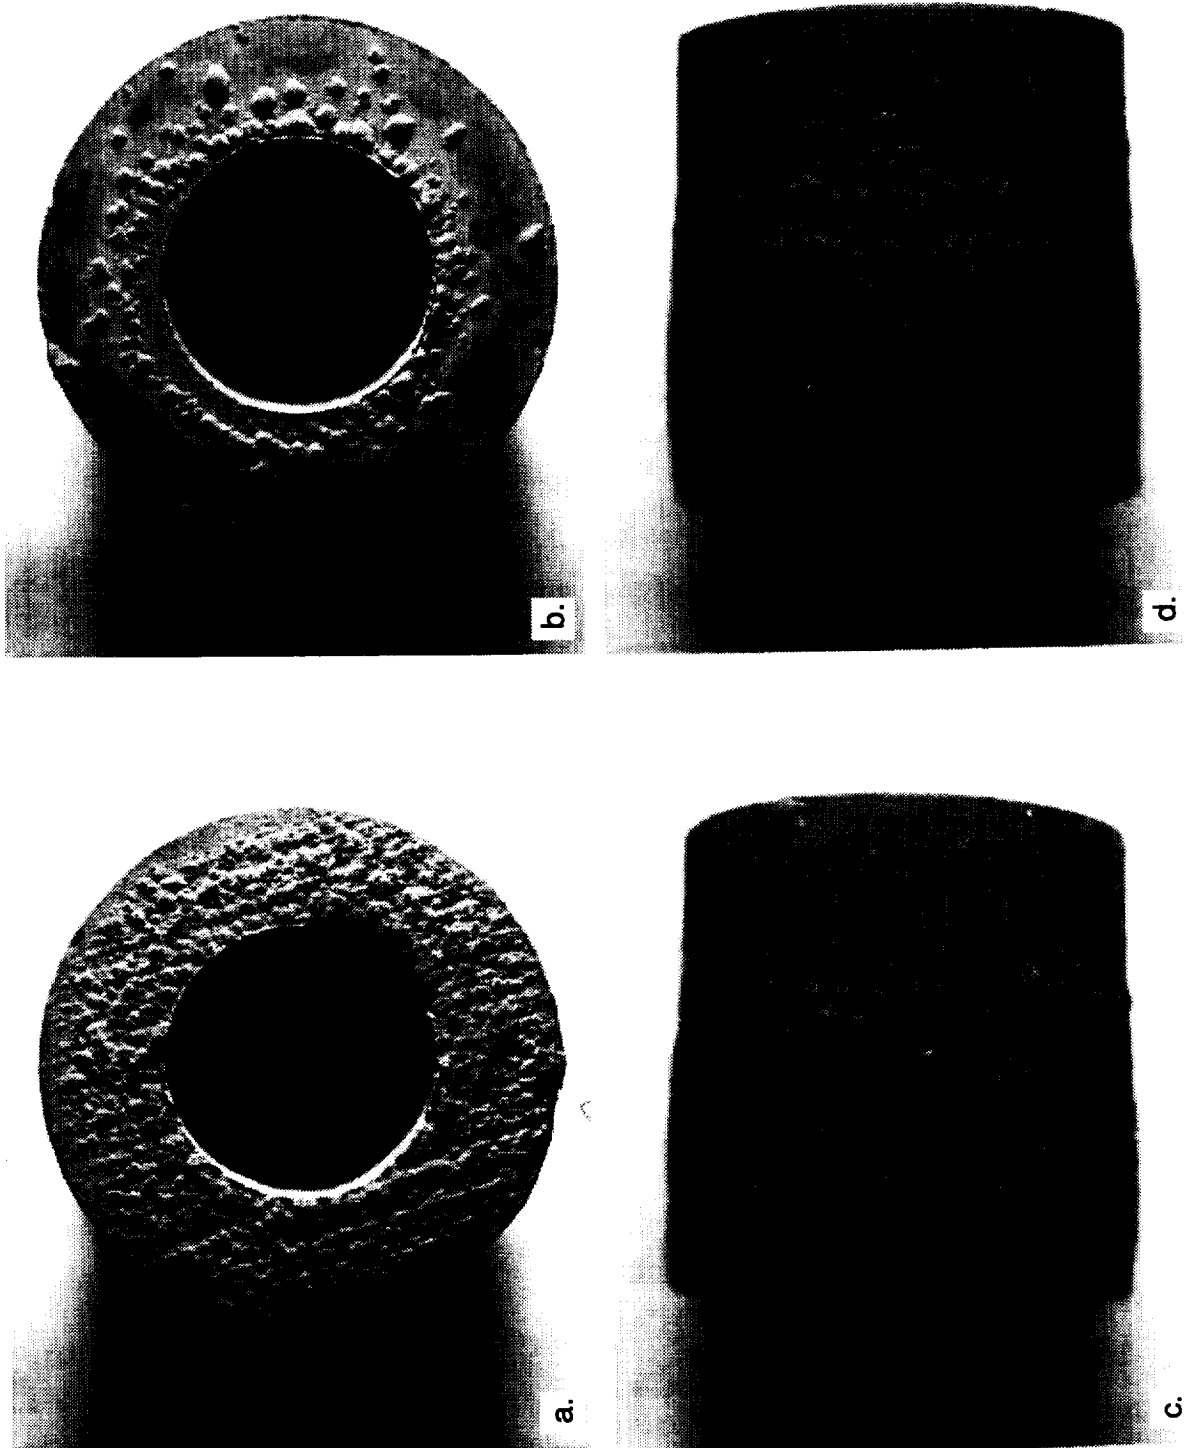
The corrosion morphology on one of the D219 samples (D219A) was very similar to that on AFN20, including the nonuniform attack on half the sample (Fig 68). However, both ends of the second D219 sample (D219B) appeared similar and the attack on the curved surface was also more uniform and not as swollen as the raised region on D219A (Fig 69). Magnified views of the scale morphology were also similar to those previously shown. Fig 70a shows a magnified view of the top of a corrosion mound (dark) on the rough end (Fig 68a) of D219A. The contrast in brightness in the BSE images (Fig 70b,c) shows that the top of the mound consists of a variety of oxides. The EDS spectra of the darkest oxides (e.g. Point 2) show that these oxides are Al-rich, presumably being primarily Al_2O_3 . The EDS spectra of the somewhat less-dark oxide in Fig 70c (point 3) contains primarily Al and a Ca peak half as high as that for Al suggesting $\text{Ca}_3\text{Al}_2\text{O}_6$. The light gray scale (point 4) contains Al and a Ni peak half the height of the Al peak, a ratio indicative of NiAl_2O_4 . EDS analysis of the bright oxide (point 1) to the right of the mound in Fig 70b shows that this oxide is Ni-rich, presumably NiO. In general, for SEM micrographs taken of the surface scales and with polished cross sections, HfO_2 , which was infrequently observed in large amounts, was very bright, Al_2O_3 was the darkest oxide, NiO was much lighter, and NiAl_2O_4 had a brightness between that of NiO and Al_2O_3 .

Fig. 68 Macrophotographs of D219A after 300 hrs showing different degrees of attack on end (a,b) and on curved surface (c,d).

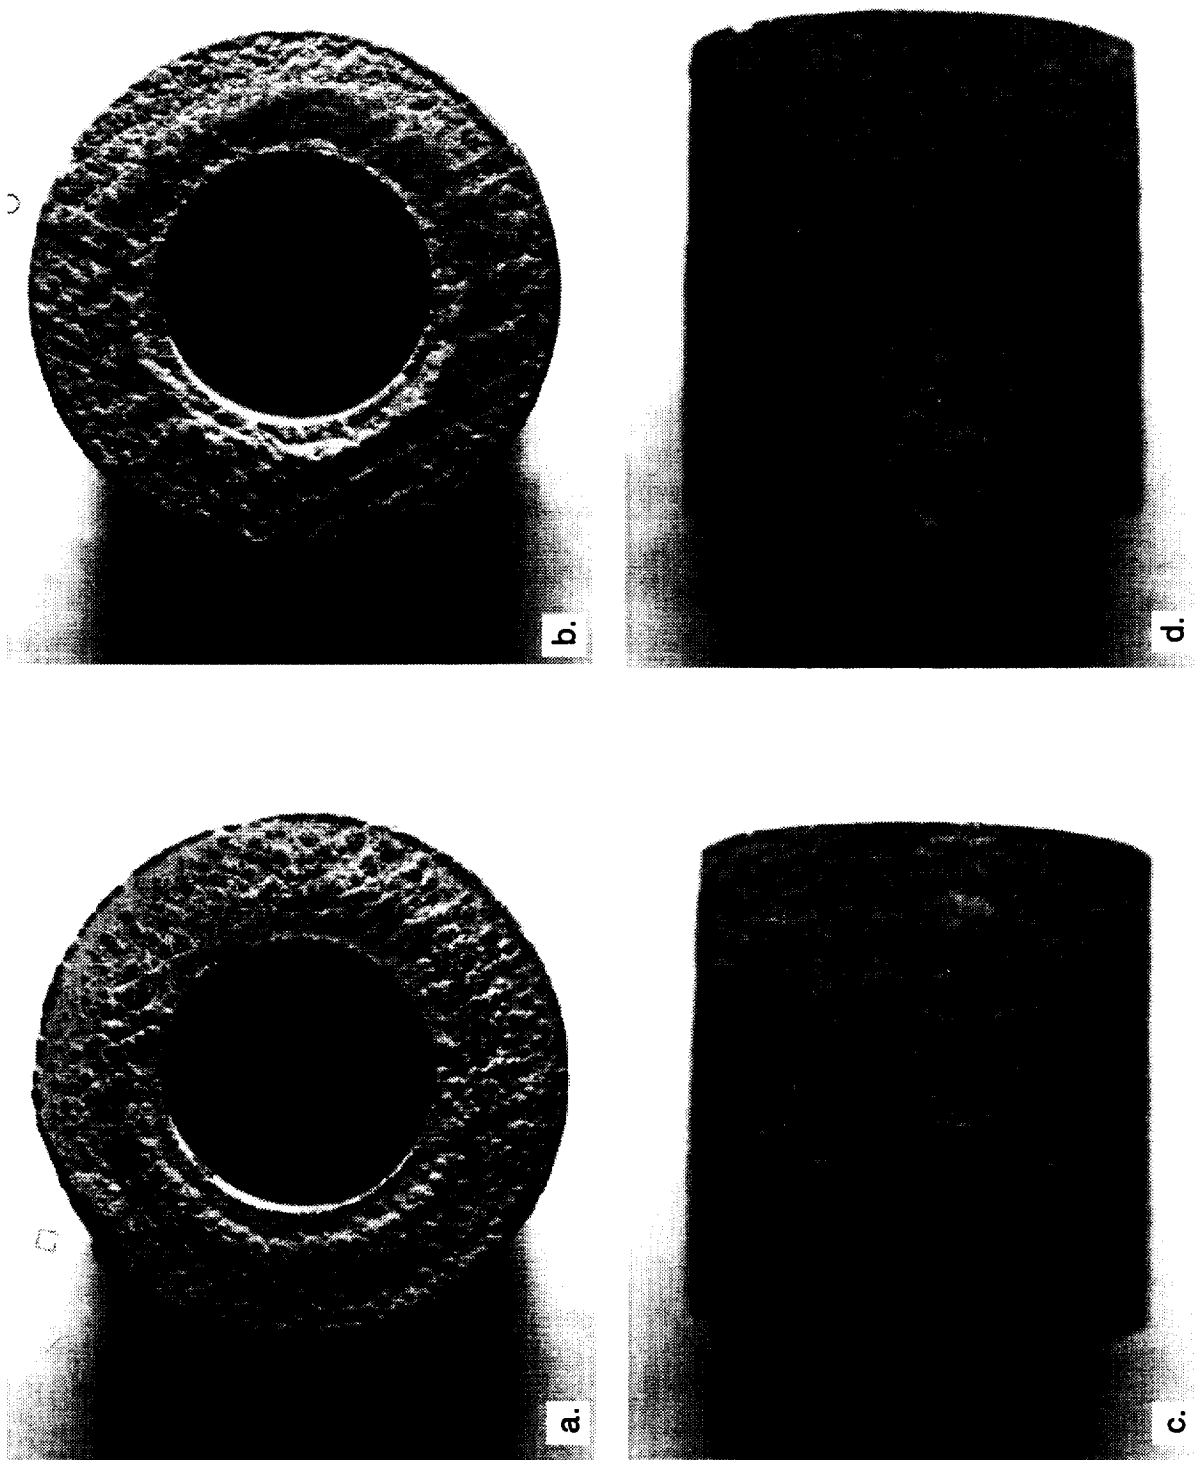
Fig. 69 Macrophotographs of D219B after 300 hrs showing similar degrees of attack on ends (a,b) and on most of curved surface (c,d).

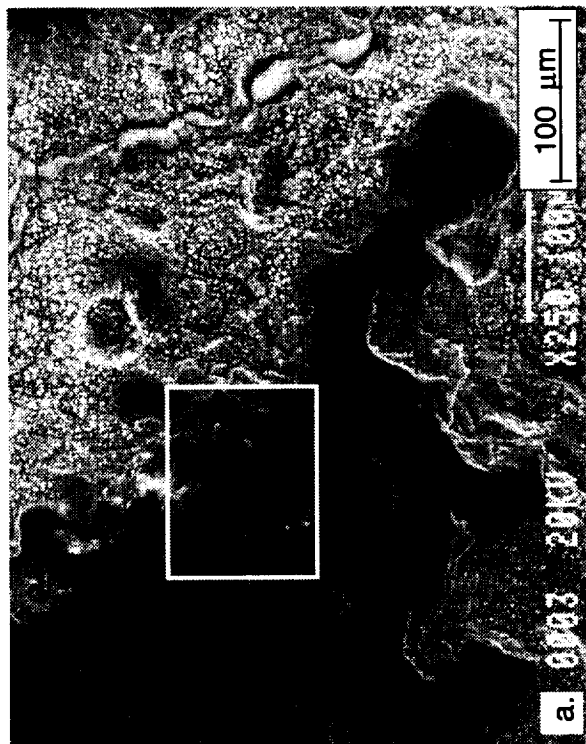
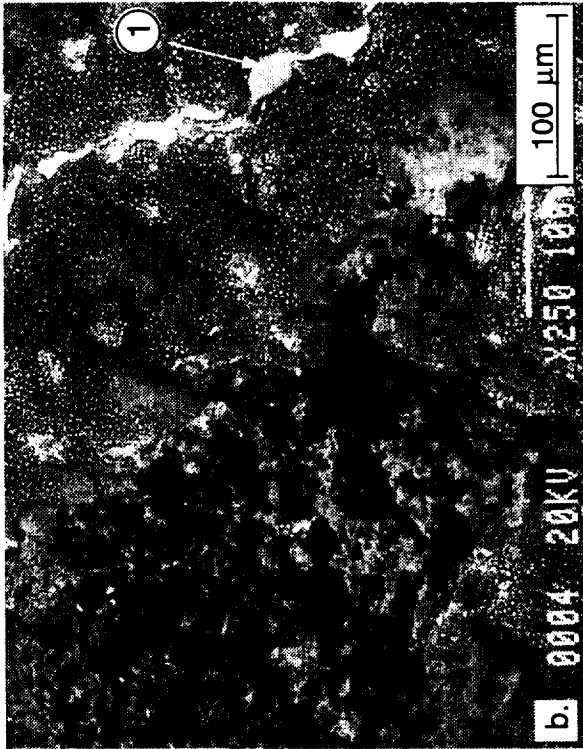
Fig. 70 SEM micrographs of the rough end of D219A after 300 cycles, (b) is a BSE image of (a) and (c) is a magnified BSE image of the box in (a).

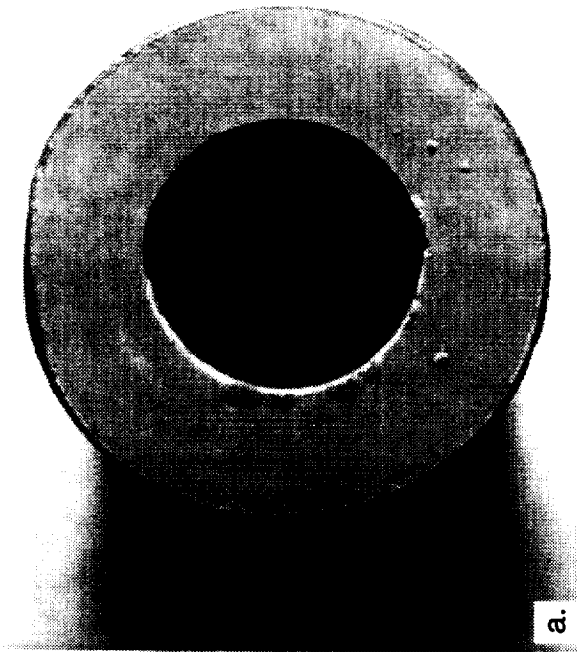
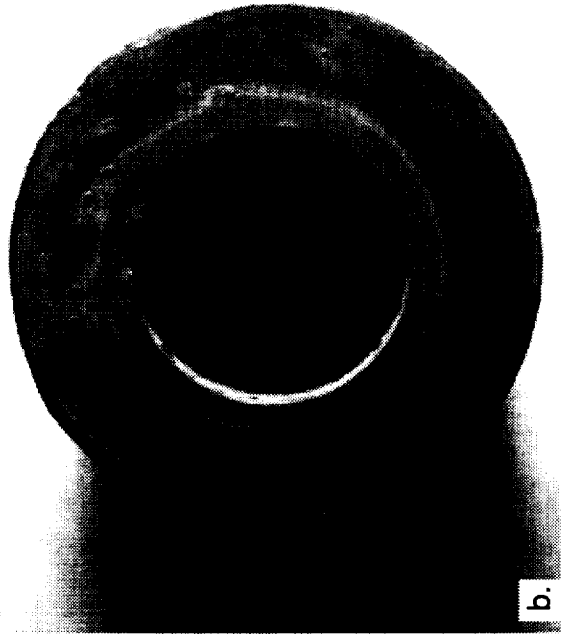
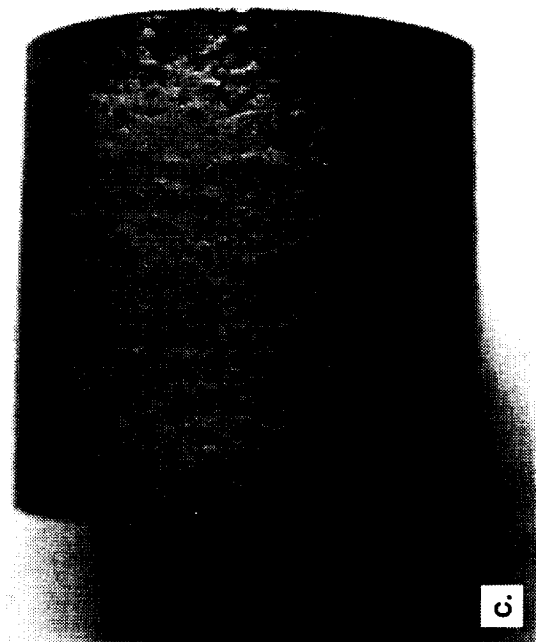
There were significant differences in the hot corrosion response between samples which were chemically milled and those mechanically polished through 600 grit SiC paper. The lower weight gain of the mechanically polished samples (Fig 38) is reflected in the corrosion morphology after 50 hrs, as shown in Figs 71 and 72. Small distinct mounds are apparent on the surface and ends although one of the samples (D219F) exhibited a localized, scaly reaction product on one portion of the curved surface (Fig 71c). The growth of the corrosion mounds after 300 hrs on D219E is shown in Fig 73. In contrast to the mechanically polished samples, most of the surface of the chemical milled samples showed a relatively uniform and continuous attack (Figs 74, 75) although one end of D219D exhibited the distinct mound formation (Fig 74a). The uniform attack on the curved surface of the chemically milled samples shows the cast dendritic structure in relief (Fig 75c), again indicating that the growth of the hot corrosion attack is inward. Although the uniform attack gives an appearance as being less severe than the large, distinct mound formation, the depth of the attack was sufficient that after only 100 hrs, large, relatively thick corroded layers began to spall from the curved surface (Fig 76). Some of the cast dendritic structure is still apparent in the intact surface (Fig 76d).

Fig. 71 Macro photographs of D219F after 50 hrs of testing (Series III). Sample surface had been polished through 600 grit SiC paper.

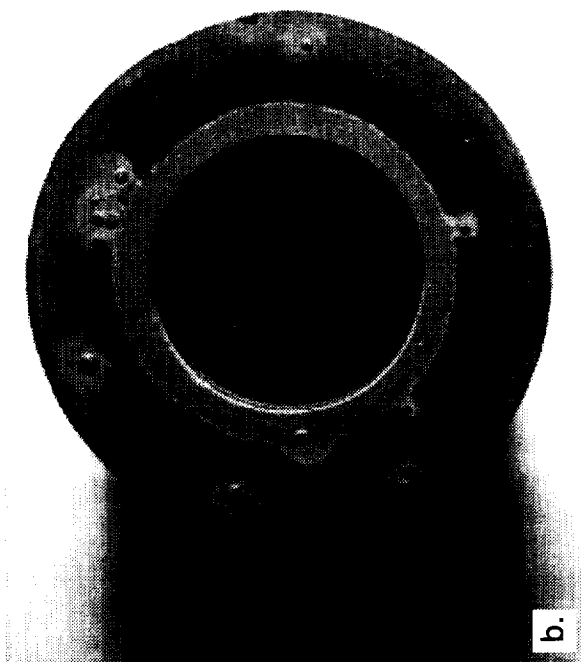
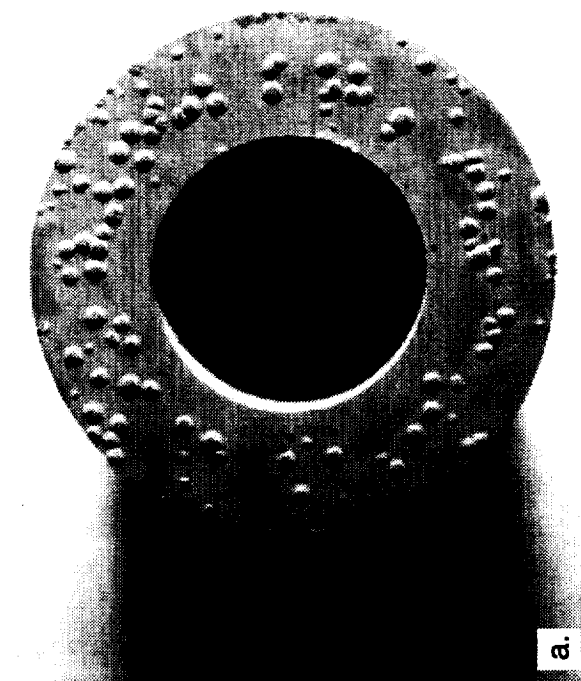
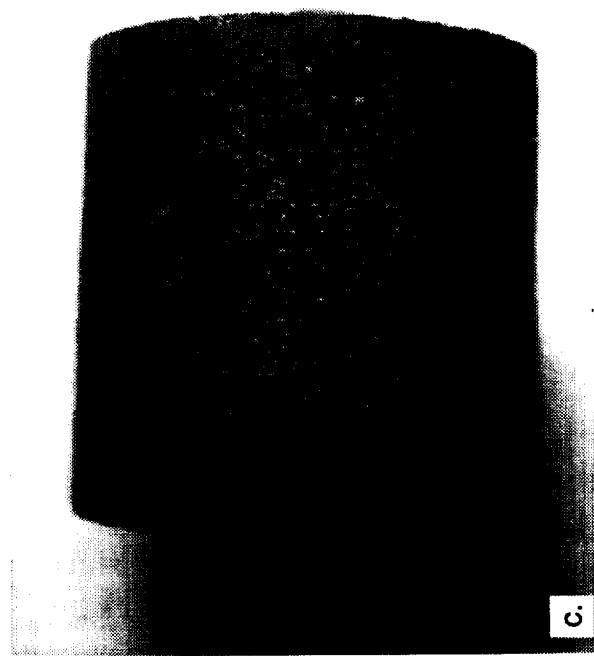
Two general types of corrosion morphology were produced on the surface, distinct mounds, and a uniform type of attack. The distinct mound formation is typified by the mounds shown on D219E after 50 hrs of testing in Fig 72 and after 300 hrs in Fig 73. The surprising feature of this type of attack is that although the mounds grew and coalesced with time, there is little indication of attack between the mounds, nor the formation of new mounds with additional testing. This feature was typical of the alloys which exhibited the distinct mound morphology. Since sea salt was continuously deposited during the test, it is curious that mounds were not continuously formed unless mound formation could occur only at select sites on the surface. Hence, mounds may have been initiated at most of these sites within the first 50-100 hrs. The surface contained many imperfections, such as cracks, pores and pits. However, the mounds did not show a preference or partiality for formation at these defects. Hence, it is possible that the mounds were initiated at a chemical inhomogeneity at or near the surface rather than some irregular surface feature. The presence of large Heusler particles near the surface are not believed to initiate mounds for several reasons. The large Heusler particles were not observed in D218, although mounds were observed on this alloy. The number of mounds formed on the surface of many of the alloys far exceeded the abundance of the large Heusler particles. Lastly, the large Heusler particles showed little tendency for accelerated attack over the β phase (Fig 107).

Fig. 72 Macro photographs of D219E after 50 hrs of testing (Series III). Sample surface had been polished through 600 grit SiC paper.

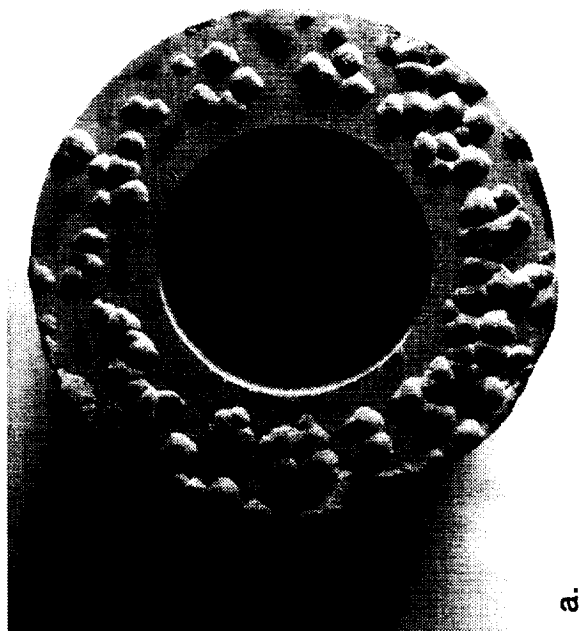
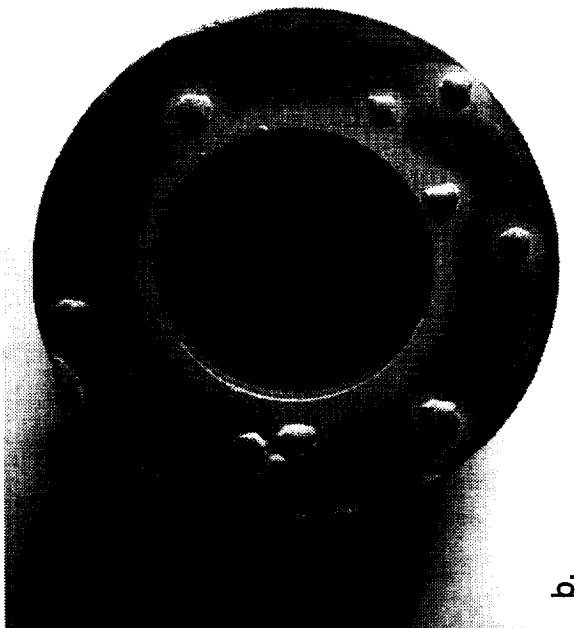
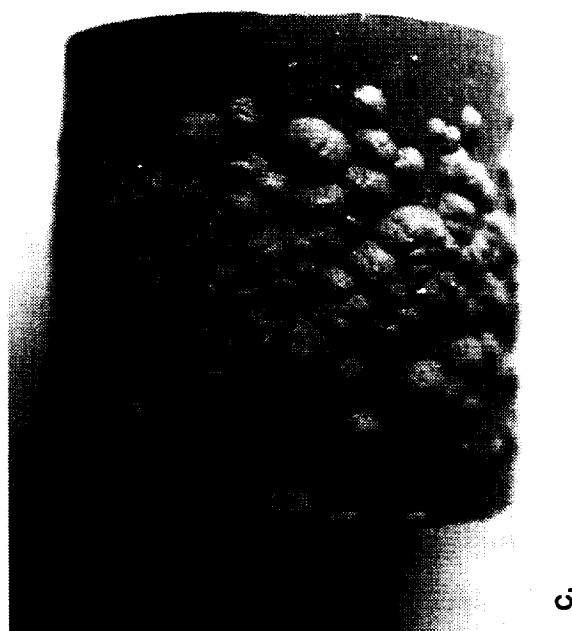
Fig. 73 Macro photographs of D219E after 300 hrs (Series III). Sample surface was polished through 600 SiC paper.

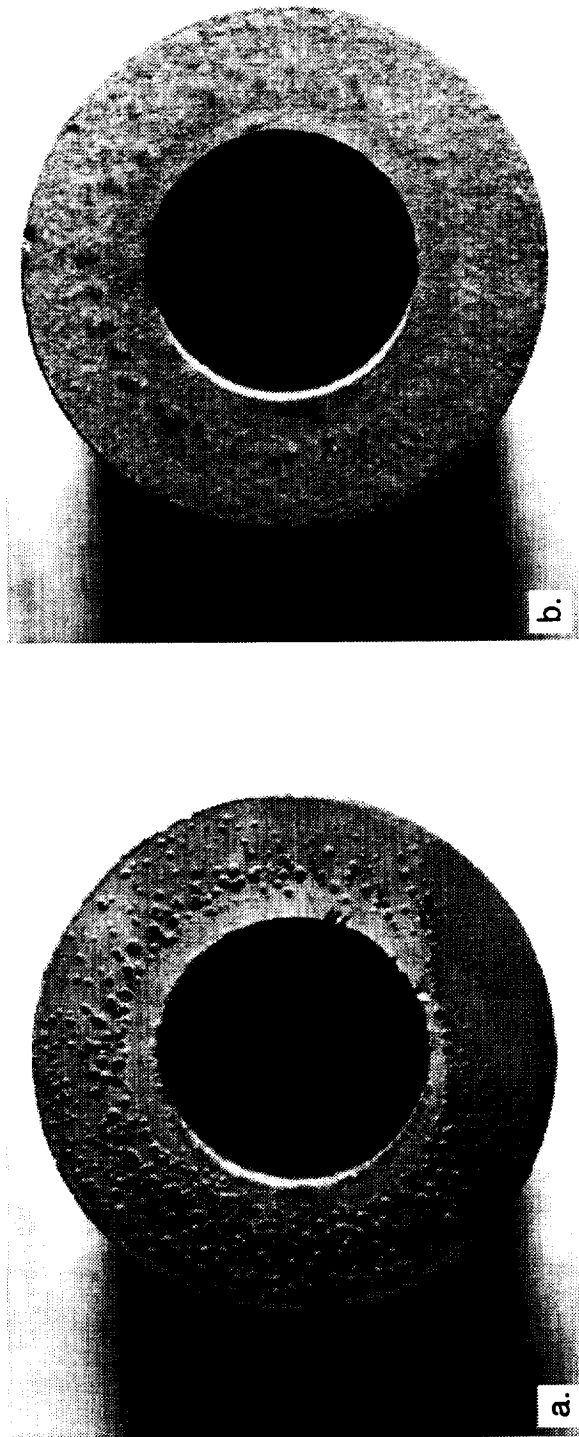
Fig 74 Macrophotographs of D219D after 50 hrs of testing (Series III). Sample surface had been chemically milled.

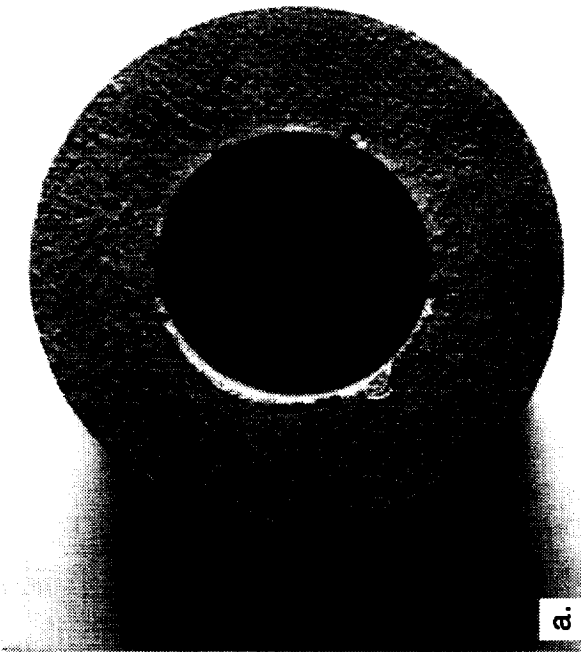
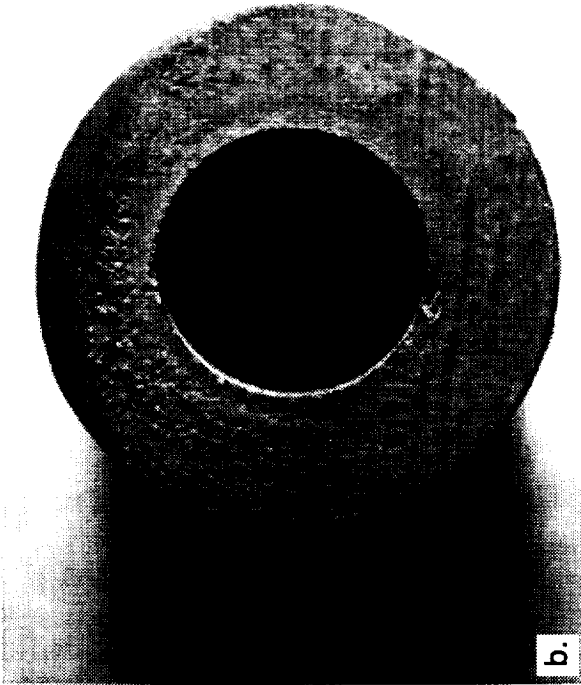
The uniform attack morphology was observed primarily on the two alloys with the poorest corrosion behavior, AFN20 and D219, but to a lesser extent on other alloys. The entire D219C sample showed this type of attack in Series III, as shown in Figs 75 and 76. However, D219D, also tested in Series III, only showed this uniform type of attack on the curved surface and on one end (Fig 74b,c). The other end showed the typical mound formation (Fig 74a). Other D219 and AFN20 samples tested in Series II also showed this form of attack on all (D219B, Fig 69) or some surfaces (AFN20, Fig 58a,d; D219A, Fig 68a). In addition, the morphology on portions of samples with better corrosion behavior also showed what appeared to be this type of attack (AFN23, Fig 49a and region 2 in Fig 49b; AFN26, Fig 82d-f). It is clear that some samples showed both distinct mound formation as well as the uniform attack (Figs 59a,b, 68a,b, 74a,b, 82a,d). As previously stated, mechanically polishing the surface of D219 resulted in a change from the uniform attack morphology to only mound formation (Figs 71-73). However, as indicated above, it

Fig. 75 Macrophotographs of D219C after 50 hrs of testing (Series III). Sample surface had been chemically milled.

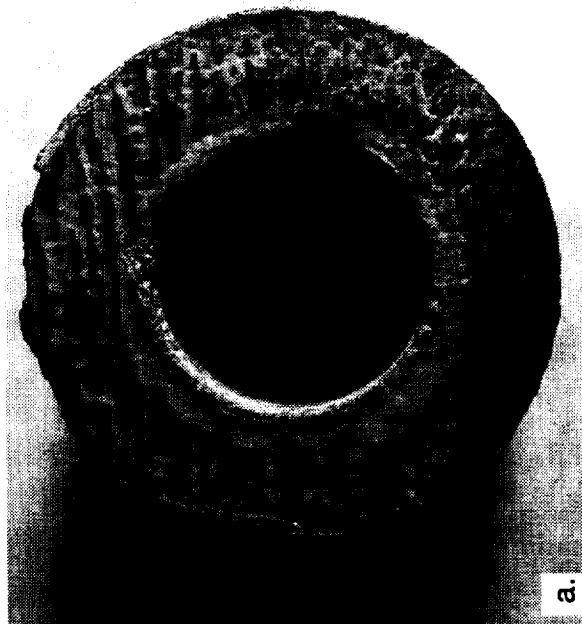
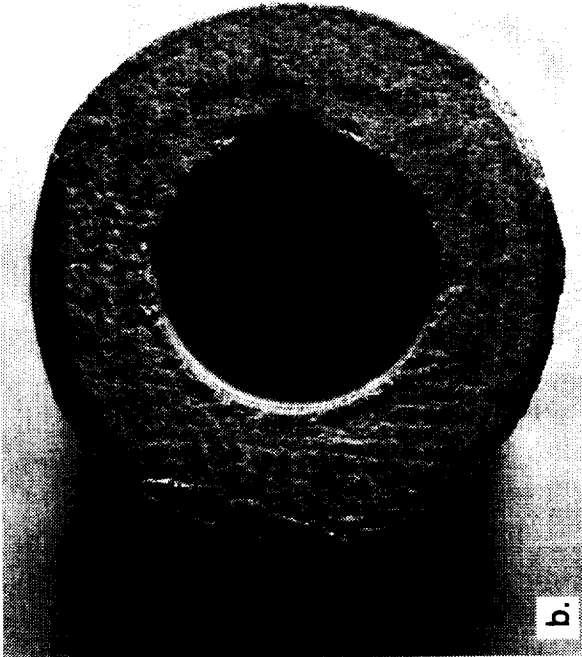
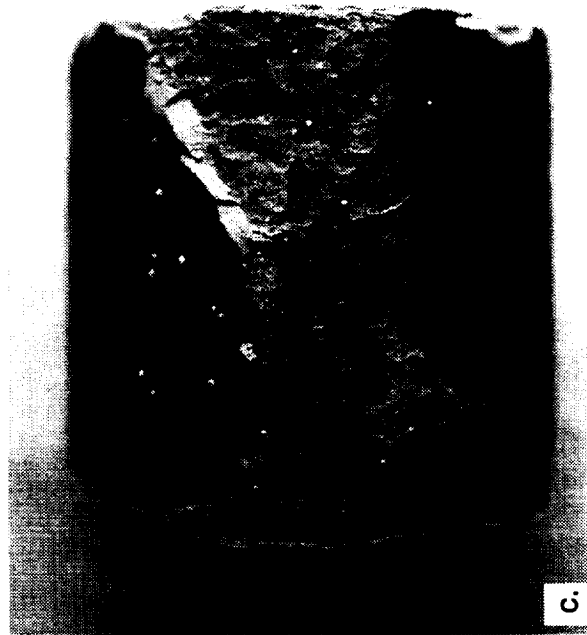
Fig. 76 Macrophotographs of D219C after 200 hrs (Series III). Sample surface was chemically milled.

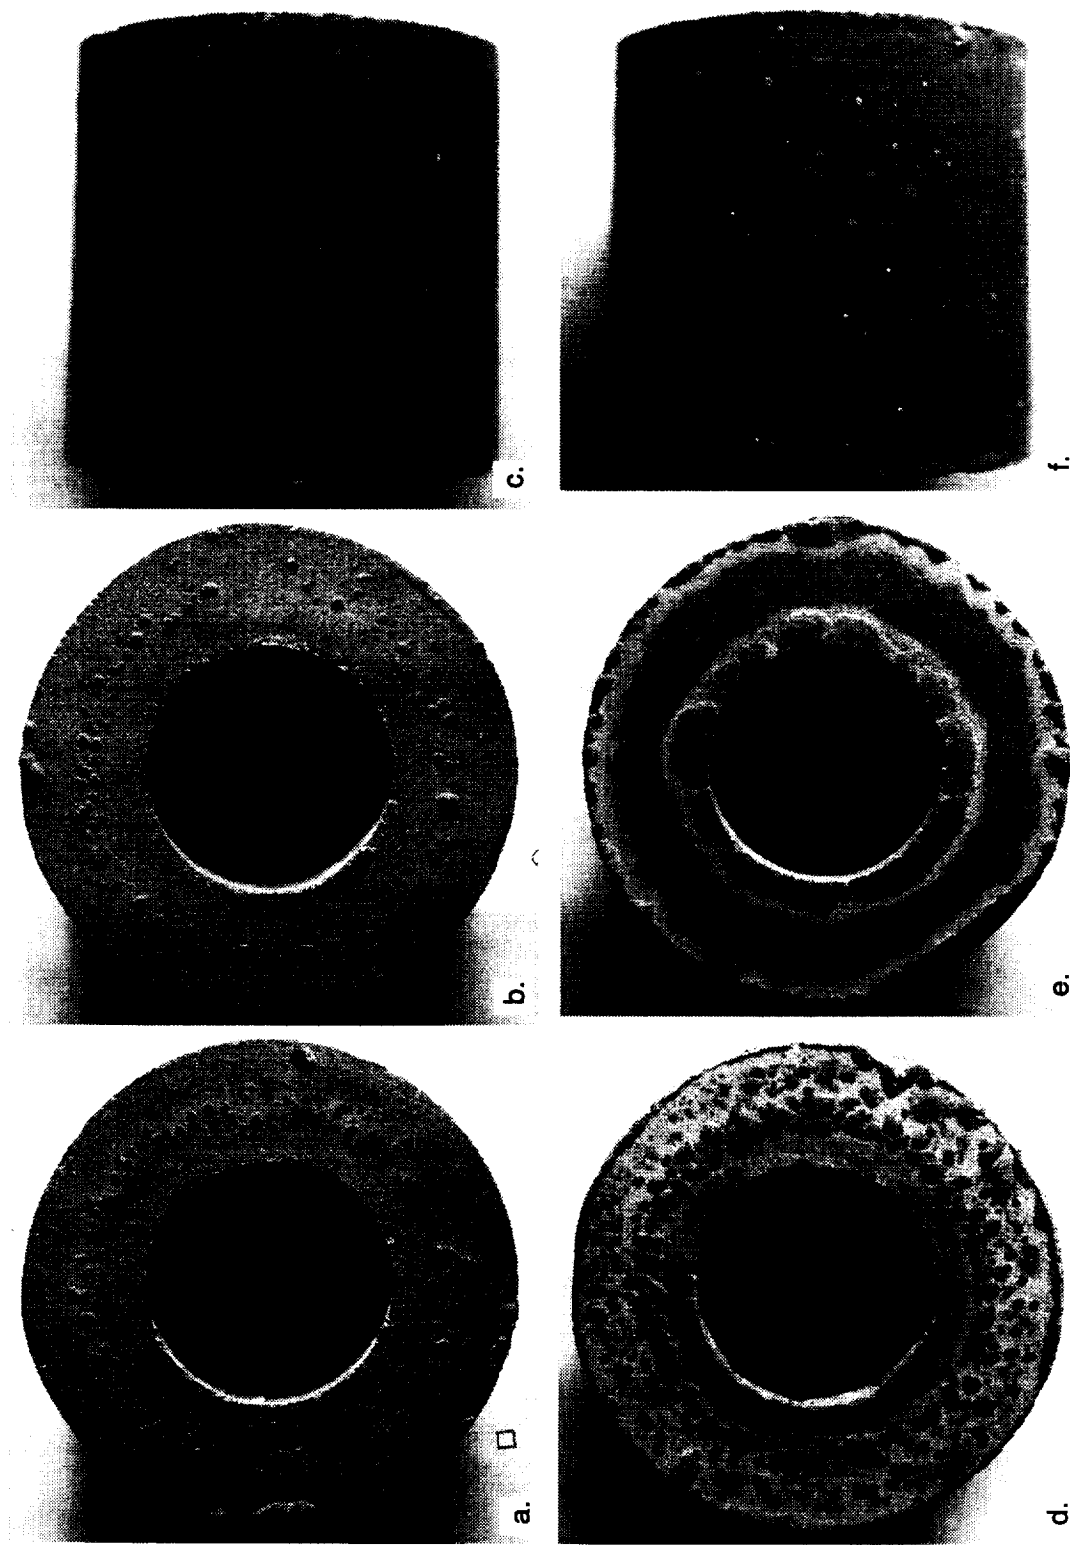
Fig. 77 Optical macrographs of the end and curved surface of AFN26 after 300 hrs (a-c) Series II, (d-f) Series III. Both samples were electropolished and chemically milled.

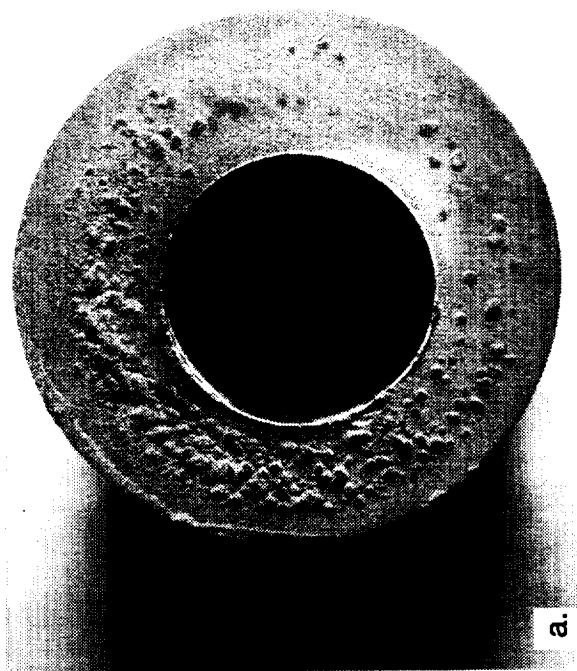
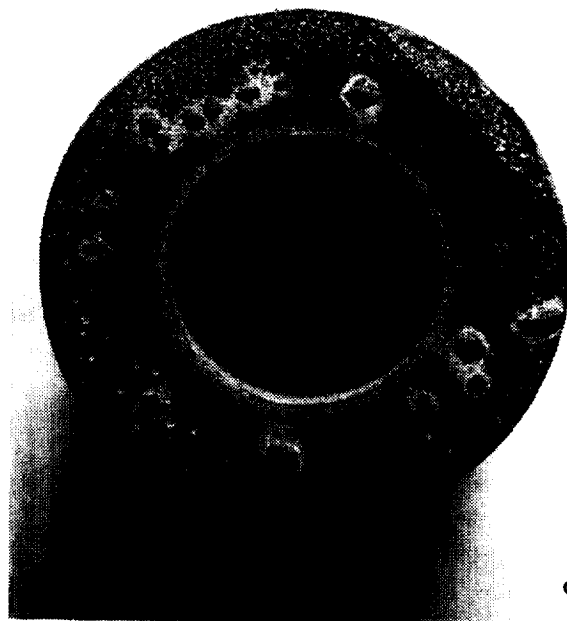
in Series III than that in Series II. AFN23 was the single exception to this observation while D218 showed no significant difference between Series II and Series III, exhibiting low weight changes during both. Although the difference in weight change was difficult to relate to the surface morphology on the D219 and AFN20 alloys which underwent significant attack during both series of tests, the difference could be observed in other alloys. Greater attack is evident on the AFN26 alloy after 300 hrs in Series III than Series II (Fig 77). The cause of the higher weight gain for AFN23 during Series II is less obvious. During Series II, this alloy had many small mounds on the end but also a localized region of heavier attack on the curved surface. During Series III, large, more distinct mounds were formed on the sample ends, however no accelerated attack was evident on the surface (Fig 78).

Fig. 78 Macrophotographs of the end and curved surface of AFN23 after 300 hrs (a,b) Series II, (c,d) Series III.
((a,b) previously shown in Fig. 49 are reproduced here for convenience.)

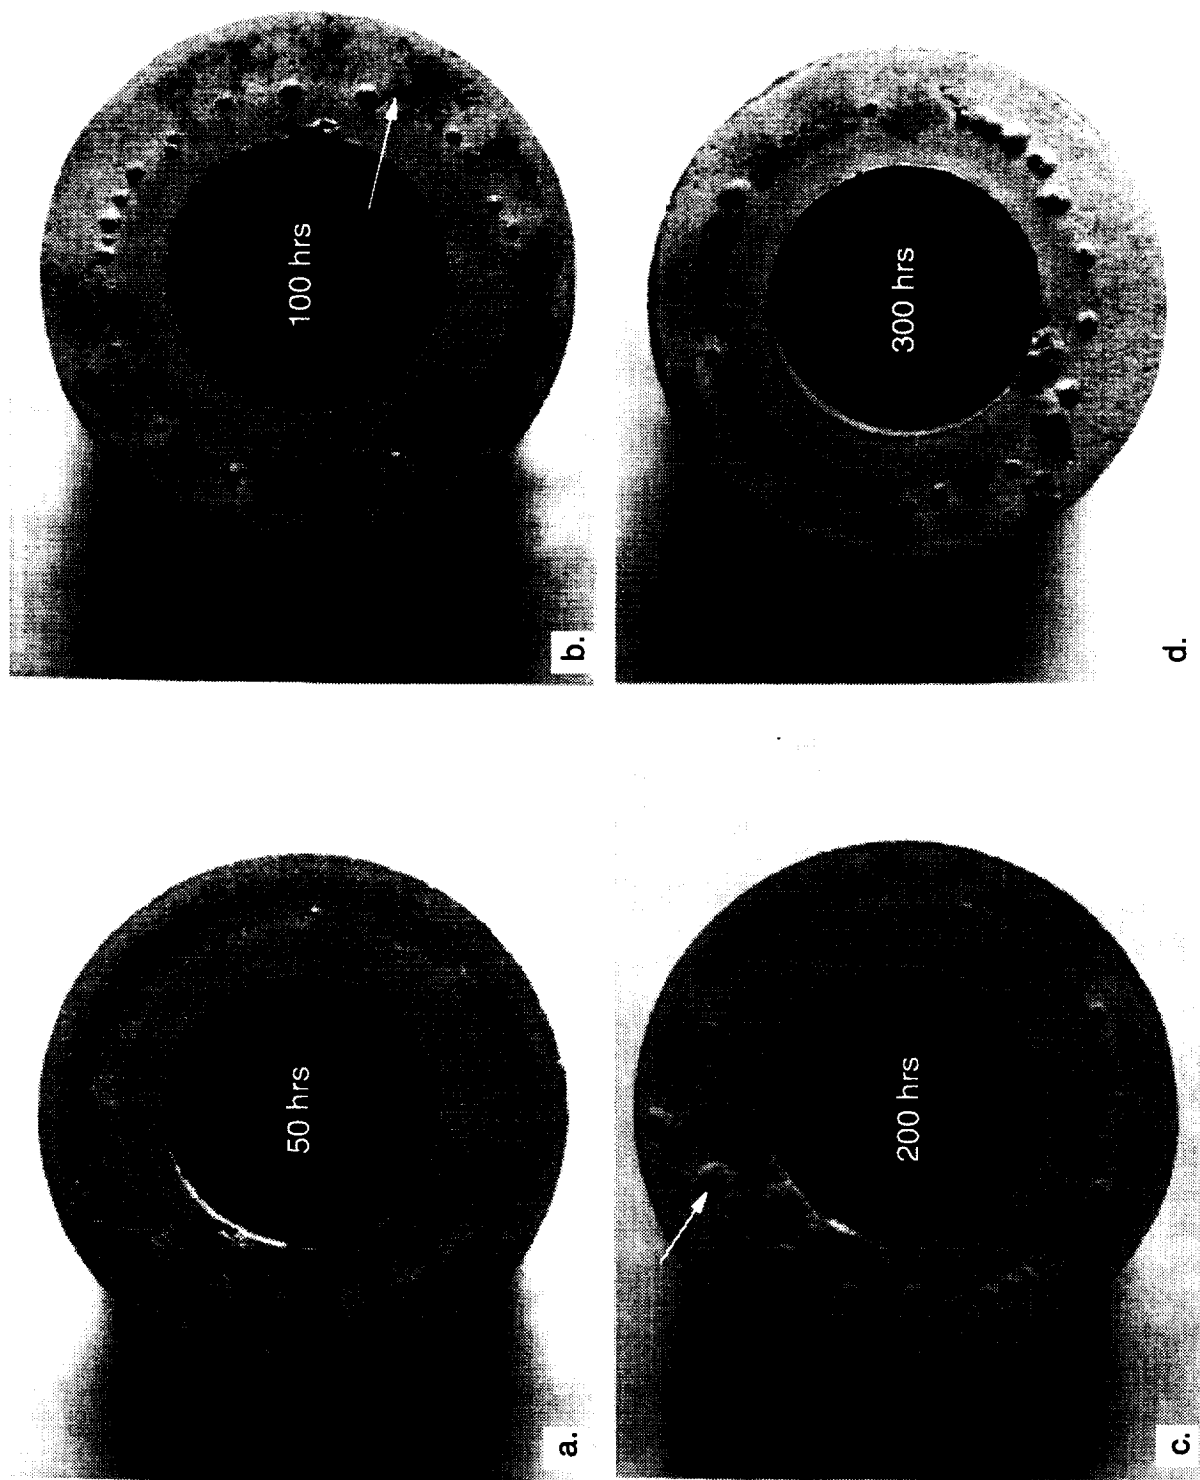
The corrosion mounds appeared at short times and grew with additional testing although few new mounds were initiated after 50-100 hrs. Most of the mounds on the end of D218B can be discerned after only 50 hrs, as shown in Fig 79. A single mound growing at a crack is apparent at 200 hrs but not at 100 (see arrow in Fig 79b,c). Most mounds are not apparent after 50 hrs in D218D which had been mechanically polished (Fig 80). However, all of the mounds visible after 300 hrs are visible after 100 hrs. These observations for D218B and D218D suggest that the surface finish may be affecting the initiation of the corrosion mounds. In D219, with a poorer corrosion behavior than that of D218, the mounds are clearly apparent after 50 hrs and grow through 300 hrs, however without any observable increase in the number of mounds (Fig 81). Both the growth of distinct mounds and the more uniform attack is evident for AFN20 in Fig 82. Even after 150 hrs, the uniform attack (Fig 82d-e) has grown but has not spread to the edges of the sample. Hence, it appears that the corrosion attack on most samples is initiated at very distinct locations and at short times with little additional attack initiated with further testing.

Fig. 79 Macrophotographs of the ends of D218B after (a) 50, (b) 100, (c) 200, and (d) 300 hrs (Series III). Sample surface was chemically milled.

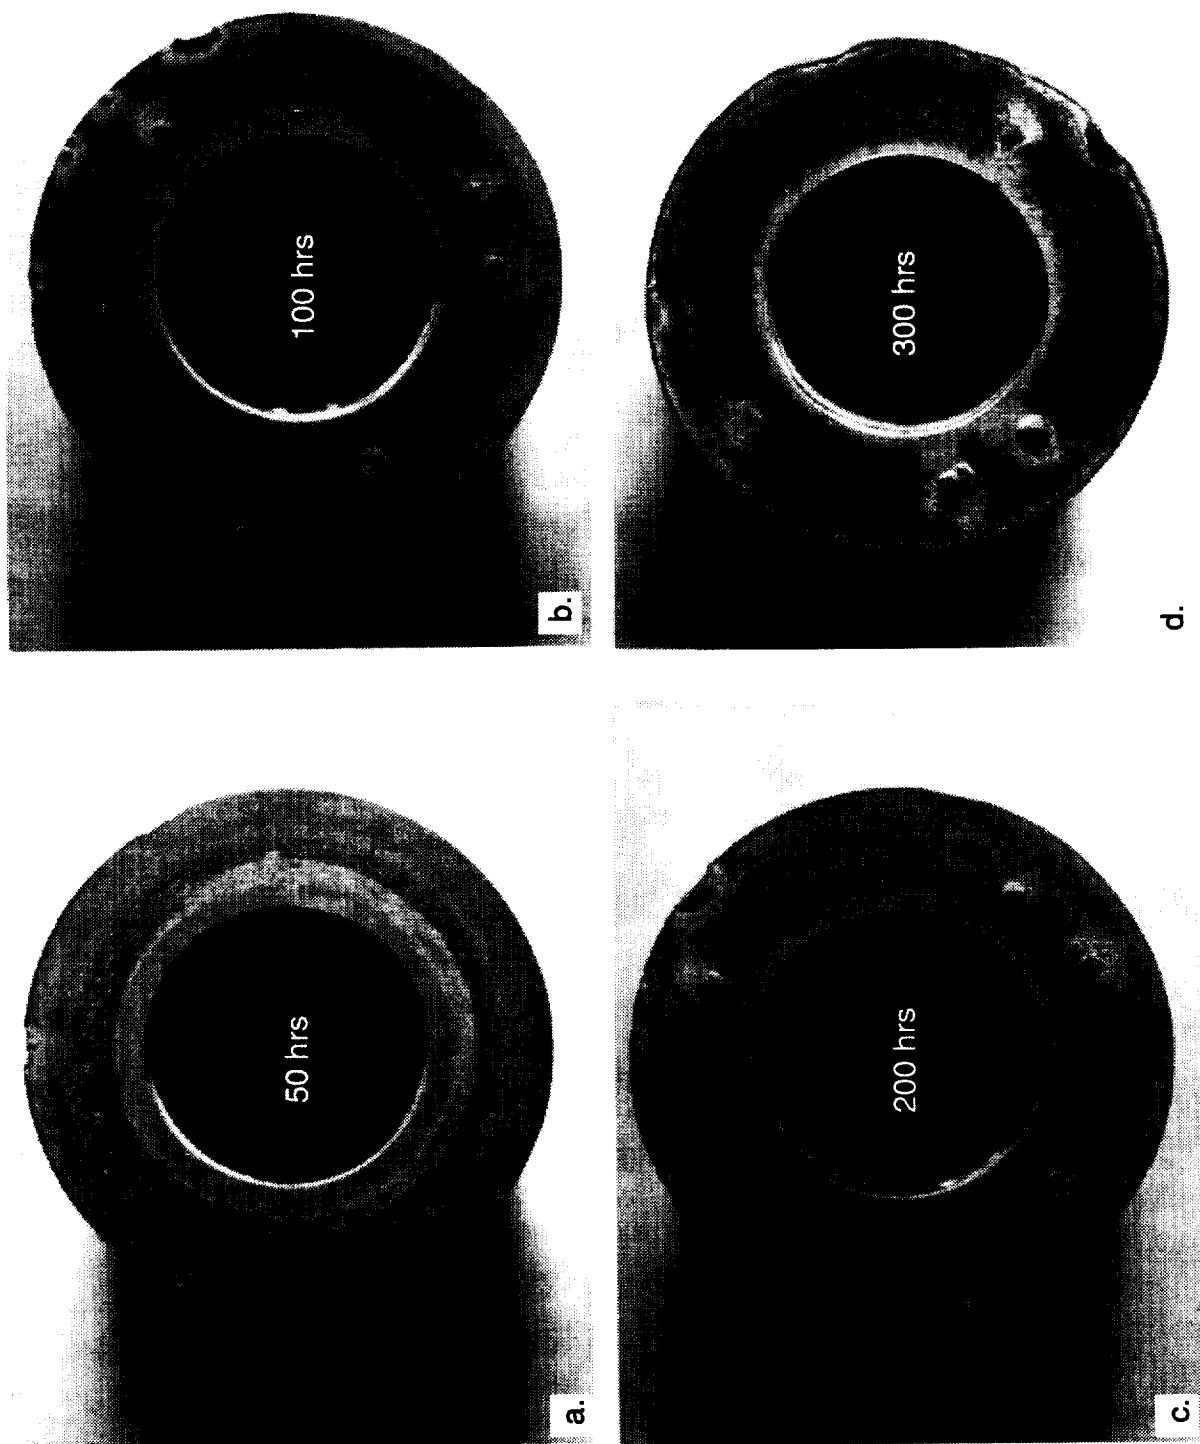
Fig. 80 Macrophotographs of the ends of D218D after (a) 50, (b) 100, (c) 200, and (d) 300 hrs (Series III). Sample surface was polished through 600 SiC paper.
